**Flood Control Project Maintenance
Levee Inspections**

Fall 2016 Levee Maintenance Deficiency Summary Report

Sutter Maintenance Yard Maintenance Area 0017

Waterway			Bank	Unit Miles
Unit No. 01 Lake County Sutter Maintenance Yard - Middle Creek			Left	3.87
	Spring (March - May)	Summer (June - August)	(September - November) Fall	Winter (December - February)
Unit Maintenance Rating (Fall Only)			U	
Date of Inspection	5/2/2016 - 5/2/2016		9/28/2016 - 9/28/2016	
DWR Inspector	Keith Millard		Tariq Chechi	
Accompanied By	Bryan Reniff Sutter Maintenance Yard		Bryan Reniff Sutter Maintenance Yard

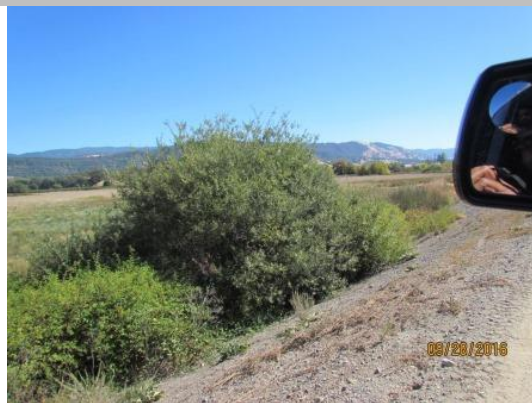
Photo 1 of 1 : FA_2016_MA0017_339_15_20161003_00029.jpg

LM Start	3.81	Rating **	M	Issue No.	15
LM End	3.84	Issue Type +	Ma	Location *	LS
Category	Earthen Levee			GPS Latitude/Longitude	
				Start	End
Item	Vegetation			39.144980 °	39.144620 °
				-122.907073 °	-122.906546 °
DWR ID	DWR_MA0017_01_s_2016_15				
Comment Code					
V2 : Remove the wild growth other than native grasses from the levee slopes.					
Inspector Comment					
Large bushes and brambles covering wire fence, limiting visibility and access.

View of the large bushes limiting visibility and access.

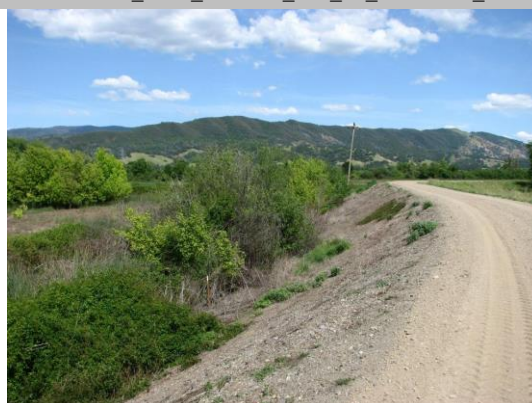
Photo 1 of 1 : FA_2016_MA0017_339_16_20160823_00008.jpg

LM Start	3.96	Rating **	M	Issue No.	16
LM End	4.03	Issue Type +	Ma	Location *	LS
Category	Earthen Levee			GPS Latitude/Longitude	
				Start	End
Item	Vegetation			39.143741 °	39.143585 °
				-122.904705 °	-122.903482 °
DWR ID	DWR_MA0017_01_s_2016_16				
Comment Code					
V2 : Remove the wild growth other than native grasses from the levee slopes.					
Inspector Comment					
Large bushes and brambles growing on wire fence on LS toe limiting visibility and access.

5/2/2016: Remove or trim dense vegetation growing on fence to allow visibility and access to L/S toe.

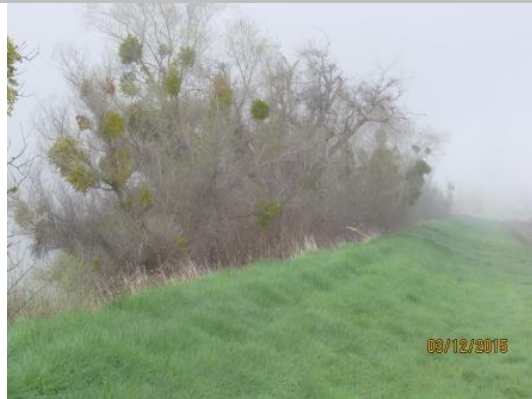
Photo 1 of 2 : FA_2016_MA0017_339_2_20160823_00001.jpg

LM Start	4.16	Rating **	U	Issue No.	2
LM End	7.10	Issue Type +	Ma	Location *	WS
Category	Earthen Levee			GPS Latitude/Longitude	
				Start	End
Item	Trim / Thin Trees			39.141894 °	39.120609 °
				-122.902201 °	-122.887166 °
DWR ID	DWR_MA0017_01_s_2012_2				
Comment Code					
T2 : Thin trees to allow visibility of the ground and room to flood fight.					
Inspector Comment					
Trees and limbs are completely obstructing visibility on crown and WS. Crown is too narrow to drive, and overgrown with weeds, brush and trees. Road follows LS toe.

View of the trees along the waterside slope and toe.

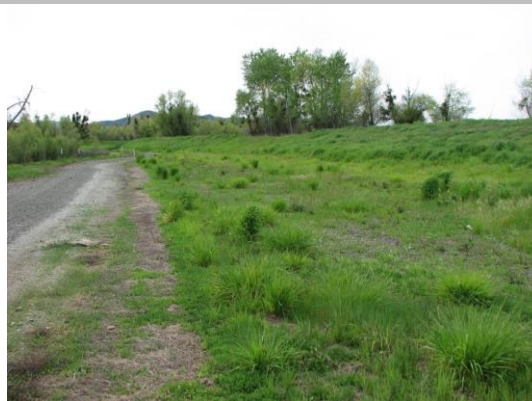
Photo 2 of 2 : FA_2016_MA0017_339_2_20160823_00002.jpg

Photo taken at LM 6.41 looking west showing overgrown LS slope of levee at right and toe road at left. Note trees obstructing visibility and access at levee crown. Crown is +/- 5 feet wide, and impassible to vehicles due to vegetation, and in some places, to pedestrians.
4/19/2016

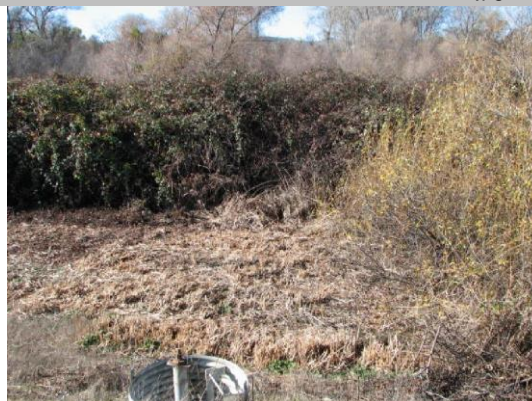
Photo 1 of 2 : UCIP_FA_2016_50817_46858.jpg

Comment Code					
Inspector Comment					
FS_ID:50817 DS_ID:846 EP_NO: 11462 Repair Type: Non-Urgent Crossing Status: Found UCIP Comments: 10/19/2016 No riser lid or slide gate wheel. (DWR Sutter Yard- A Freitag)6/14/2016 No riser lid and no wheel to operate screw gate.4/23/2015 Still no lid on riser and wheel to operate slide gate is missing.7/3/2014 Same as last inspection.12/23/2013 Same as last inspection.8/2/2013 Same as last inspection.12/13/2012 No lid on riser-may or may not be an issue. FIELD_STRUCT_DESC: 24-inch corrugated metal drainage pipe through the levee, 19 feet below the crown. Slide gate in 36-inch corrugated metal pipe (CMP) riser on the waterside (WS) slope. (Automatic Board Order (ABO) issued as Permit No. 11462, 1975 - Hobson) [Additional Reference(s): DWR Levee Log, 2005]. FS Date: 11/21/2016 12:11:29 PM

Slide gate in CMP riser on WS slope.

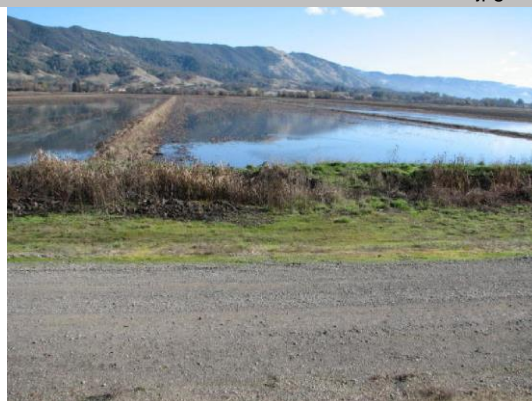
Photo 2 of 2 : UCIP_FA_2016_50817_46857.jpg

LS toe at approximate location of pipe inlet.

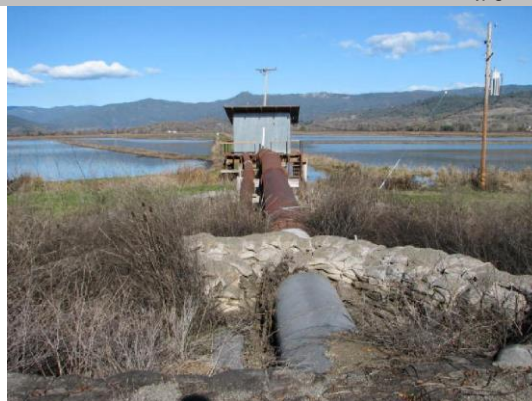
Photo 1 of 2 : UCIP_FA_2016_50818_46860.jpg

FS_ID:50818
DS_ID:847
EP_NO: 11469
Repair Type: Non-Urgent
Crossing Status: Found
UCIP Comments: 10/19/2016 Sack ring still in place. (DWR Sutter Yard- A Freitag) 6/14/2016 Sack ring is still built up underneath the pipes. 4/23/2015 Sack ring is still built up underneath the pipes. 7/3/2014 Same as last inspection. 12/23/2013 Same as last inspection. 8/2/2013 Same as last inspection. 12/13/2012 flood fight materials-ring levees around both LS and WS slopes at pipe crossing. This may or may not be an issue.
FIELD_STRUCT_DESC: 1 of 2: 16-inch steel drainage pipe through the levee, 5 feet below the crown. Drainage pumping plant on the landside (LS). Flap gate on the waterside (WS) end. (Automatic Board Order (ABO) issued as Permit No. 11469, 1975 - RD 2070). [Additional Reference(s): DWR Levee Log, 2005. USACE Sacramento O&M Manual 506.3, August 1961, (HLM 5.43)].
FS Date: 11/21/2016 12:11:57 PM

Pumping plant, pipes, and ring levees on LS toe.

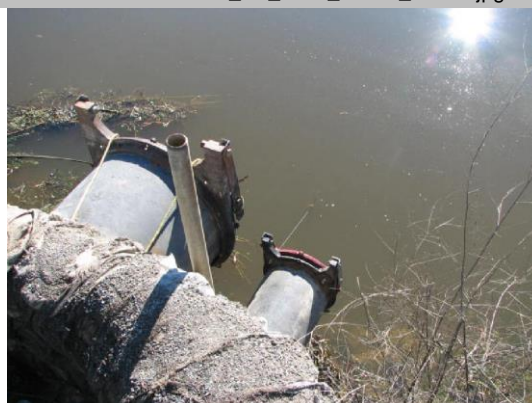
Photo 2 of 2 : UCIP_FA_2016_50818_46859.jpg

16-inch pipe, flap gate, air vent, and ring levee on WS slope.

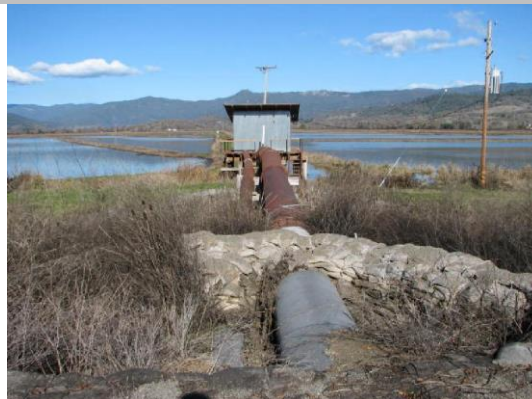
Photo 1 of 2 : UCIP_FA_2016_50819_46864.jpg

FS_ID:50819
DS_ID:853
EP_NO: 11469
Repair Type: Non-Urgent
Crossing Status: Found
UCIP Comments: 10/19/2016 Sack ring still in place. (DWR Sutter Yard- A Freitag) 6/14/2016 Sack ring is still built up underneath the pipes. 4/23/2015 Sack ring still built up underneath the pipes. 7/3/2014 Same as last inspection. 12/23/2013 Same as last inspection. 8/2/2013 Same as last inspection. 12/13/2012 flood fight materials-ring levees around both LS and WS slopes at pipe crossing. This may or may not be an issue.
FIELD_STRUCT_DESC: 2 of 2: 36-inch steel drainage pipe through the levee, 5 feet below the crown. Flap gate and air vent on the waterside (WS) slope. (Automatic Board Order (ABO) issued as Permit No. 11469, 1975 - RD 2070). [Additional Reference(s): DWR Levee Log, 2005. USACE Sacramento O&M Manual 506.3, August 1961, (HLM 5.43)].
FS Date: 11/21/2016 12:12:31 PM

Pipes and pump house on LS toe with ring levees.

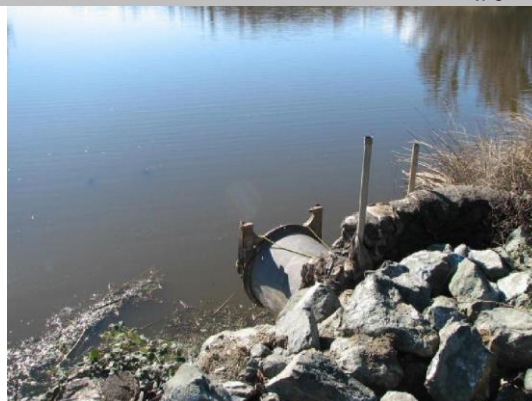
Photo 2 of 2 : UCIP_FA_2016_50819_46863.jpg

Pipe, flap gate, air vent, and sandbags on WS slope.

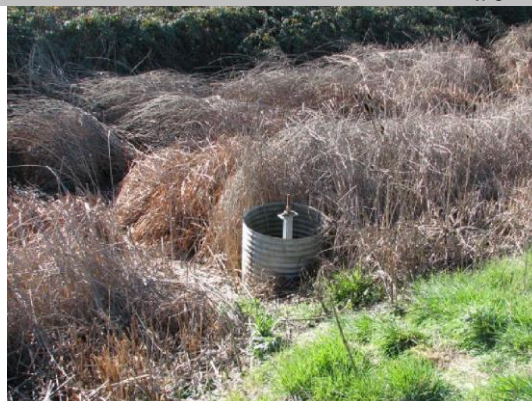
Photo 1 of 2 : UCIP_FA_2016_50820_46866.jpg

Comment Code					
Inspector Comment					
FS_ID:50820 DS_ID:848 EP_NO: 11457 Repair Type: Non-Urgent Crossing Status: Found UCIP Comments: 10/19/2016 No riser lid or slide gate wheel. (DWR Sutter Yard- AFreitag)6/14/2016 No riser lid and no wheel to operate screw gate.4/23/2015 No cover on riser and no wheel to operate gate.7/3/2014 Same as last inspection.12/23/2013 Same as last inspection.8/2/2013 Handle to operate gate was in place but still no cover on riser.12/13/2012 No cover on CMP riser and no handle for actuating gate. This may or may not be an issue. FIELD_STRUCT_DESC: 24-inch drainage pipe under patrol road and through the levee, 13.5 feet below the crown. Concrete "U" shaped headwall on the landside (LS) end. Slide gate in 36-inch corrugated metal pipe (CMP) riser on the waterside (WS) slope. Riser unit is mounted on concrete base. (Automatic Board Order (ABO) issued as Permit No. 11457, 1975 - Crawford). [Additional Reference(s): DWR Levee Log, 2005. USACE Sacramento O&M Manual 506.3, August 1961, (HLM 5.87)]. FS Date: 11/21/2016 12:12:57 PM

36-inch CMP riser and slide gate on WS slope.

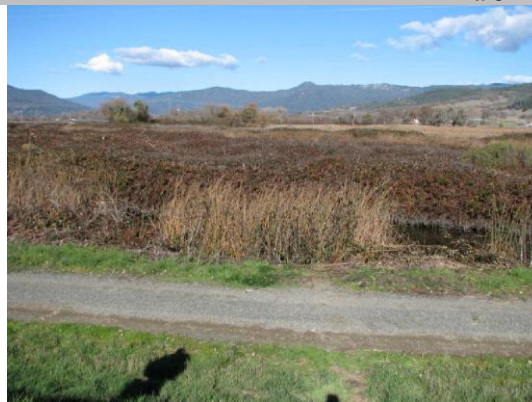
Photo 2 of 2 : UCIP_FA_2016_50820_46865.jpg

Approximate location of inlet on LS toe (not visible).

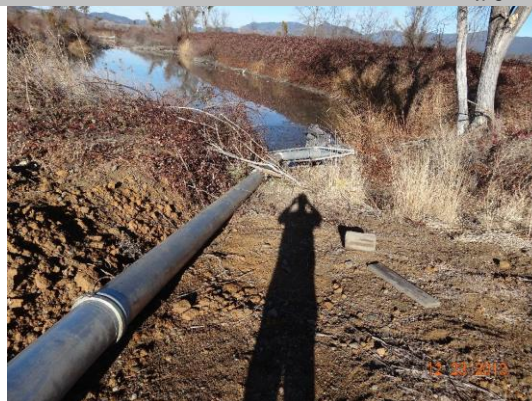
Photo 1 of 1 : UCIP_FA_2016_50823_47920.jpg

Comment Code					
Inspector Comment					
FS_ID:50823 DS_ID:20589 EP_NO: N/A Repair Type: Non-Urgent Crossing Status: Found UCIP Comments: 10/19/2016 12" pipe not present for this inspection. (DWR Sutter Yard- A Freitag)6/14/2106 12" pipe was removed from the roadway. Portable pump was not found on the bank this time.4/23/2015 12" pipe still ran over the top of roadway. 7/3/2014 Same as last inspection.12/23/2013 No signs of 12" pvc. Portable tow-pump was lowered down on waterside with 12" pipe ran over roadway.8/2/2013 Same as last inspection.12/13/2012 No permit for crossing. FIELD_STRUCT_DESC: *REMOVED* 12-inch high-density polyethylen (HDPE) drainage pipe through the levee, 1.5 feet below the crown. No permit has been identified since crossing was field discovered in 2012. FS Date: 11/21/2016 12:14:52 PM

Portable pump on WS and temporary piping over roadway

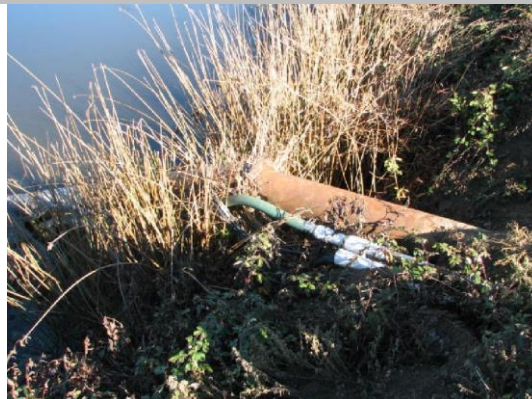
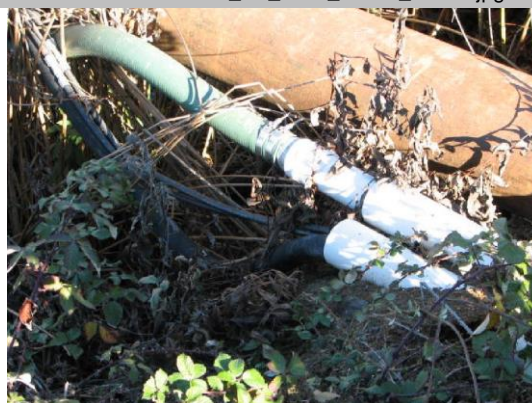
FS_ID:50824
DS_ID:20587
EP_NO: N/A
Repair Type: Urgent
Crossing Status: Found
UCIP Comments: 10/19/2016 WS erosion still present. (DWR Sutter Yard- A Freitag)6/14/2016 WS erosion is still present. (DWR Sutter Yard - a Freitag)4/23/2015 Erosion on WS shoulder is still present. (DWR Sutter Yard - a Freitag)7/3/2014 Same as last inspection. (DWR Sutter Yard - a Freitag)12/23/2013 Same as last inspection. (DWR Sutter Yard - a Freitag)8/2/2013 Erosion on WS shoulder above pipes. (DWR Sutter Yard - a Freitag)12/13/2012 No permit for this crossing. This is a primer line, used to fill up main pipe before its pump is turned on (Permit No. 11467). (DWR UCIP - wwyliie)
FIELD_STRUCT_DESC: 4-inch polyvinyl (PVC) conduit through the levee, 2 feet below the crown with plastic pipe running through it to pump on the landside (LS). No permit has been identified since crossing was field discovered in 2012.
FS Date: 11/21/2016 12:15:33 PM

4-inch pvc pipe with green flexible pipe running through it on WS shoulder.

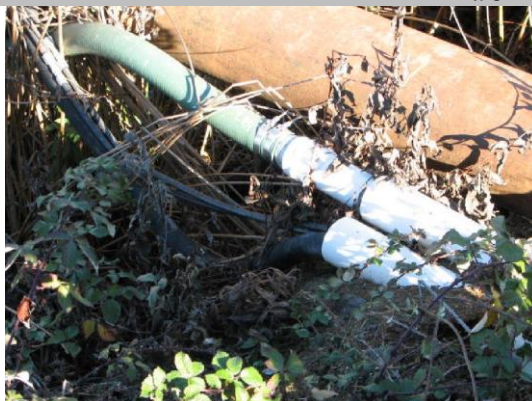
Photo 1 of 2 : UCIP_FA_2016_50825_46874.jpg

FS_ID:50825
DS_ID:20588
EP_NO: N/A
Repair Type: Urgent
Crossing Status: Found
UCIP Comments: 10/19/2016 WS erosion still present. (DWR Sutter Yard- AFreitag)6/14/2016 WS erosion is still present. (DWR Sutter Yard - afreitag)4/23/2015 Erosion still present on WS shoulder. (DWR Sutter Yard - afreitag)7/3/2014 Same as last inspection. (DWR Sutter Yard - afreitag)12/23/2013 Same as last inspection. (DWR Sutter Yard - afreitag)8/2/2013 Erosion on WS shoulder above pipes. (DWR Sutter Yard - afreitag)12/13/2012 No permit for this crossing. It is unclear what these hydraulic lines are for, but it is probably the works for a hydraulic butterfly valve at the outlet. (DWR UCIP - wwyllie)
FIELD_STRUCT_DESC: 4-inch polyvinyl chloride (PVC) conduit through the levee, 2 feet below the crown with hydraulic lines running through it to pump on the landside (LS) shoulder. No permit has been identified since crossing was field discovered in 2012.

Pipe and hydraulic lines on WS shoulder.

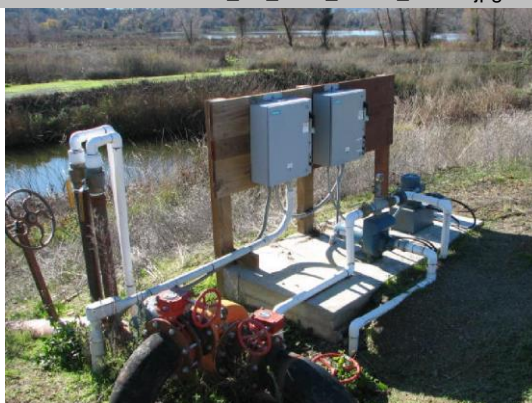
Photo 2 of 2 : UCIP_FA_2016_50825_46873.jpg

Pump station on LS shoulder, see hydraulic pump at right.

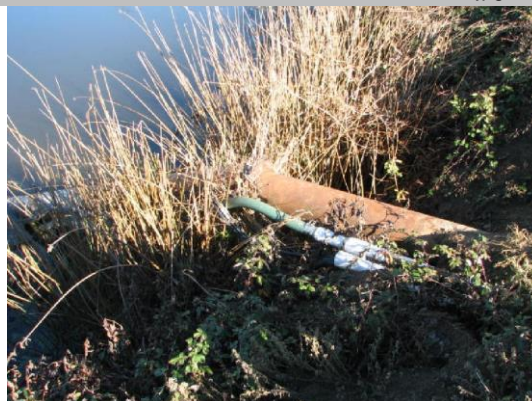
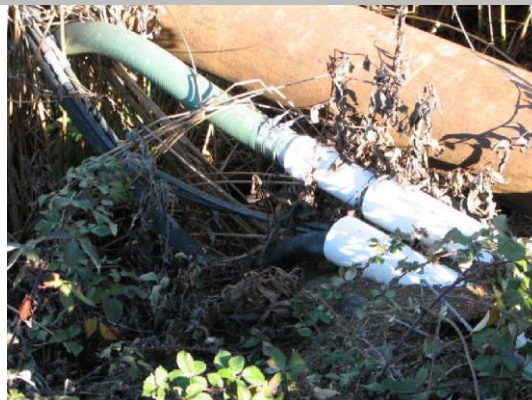
FS_ID:50826
DS_ID:850
EP_NO: 11467
Repair Type: Urgent
Crossing Status: Found
UCIP Comments: 10/19/2016 WS erosion still present. (DWR Sutter Yard- A Freitag)6/14/2016 WS erosion is still present. (DWR Sutter Yard - a Freitag)4/23/2015 Same as last inspection. (DWR Sutter Yard - a Freitag)7/3/2014 Same as last inspection. (DWR Sutter Yard - a Freitag)12/23/2013 Same as last inspection. (DWR Sutter Yard - a Freitag)8/2/2013 Same as last inspection. (DWR Sutter Yard - a Freitag)12/13/2012 This pipe and appurtenances do not match what was described in the permit (PN: 11467). Does not appear to be in compliance with board regulations. (DWR UCIP - wwyliie)
FIELD_STRUCT_DESC: 12-inch steel drainage pipe through the levee, 2-feet below the crown. Butterfly valve on the landside (LS) shoulder. Pump and electric panel along with multiple valves and appurtenances on the LS shoulder. (Automatic Board Order (ABO) issued as Permit No. 11467, 1975 - Modglin[Additional Reference(s): DWR Levee Log, 2005. USACE Sacramento O&M Manual 506.3, August 1961, (HLM 6.11)]).

12-inch pipe and appurtenances on WS shoulder.

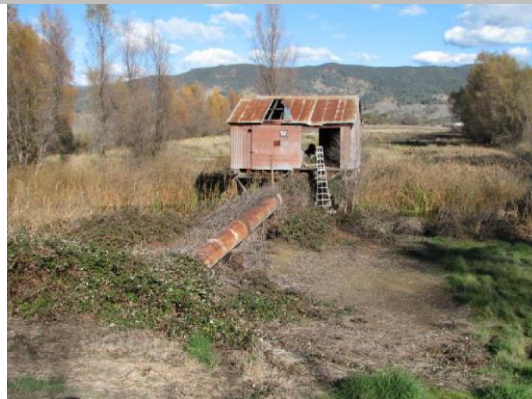
Photo 1 of 2 : UCIP_FA_2016_50827_46884.jpg

FS_ID:50827
DS_ID:851
EP_NO: 11467
Repair Type: Non-Urgent
Crossing Status: Found
UCIP Comments: 10/19/2016 Abandoned- should be done so properly.
(DWR Sutter Yard- AFreitag)6/14/2016 Abandoned
crossing.4/23/2015 Same as last inspection. Pipe still needs to be
properly abandoned.7/3/2014 Same as last inspection.12/23/2013
Same as last inspection.8/2/2013 Same as last
inspection.12/13/2012 Pipe should be properly abandoned.
FIELD_STRUCT_DESC: *ABANDONED* 1 of 2: 16-inch steel drainage
pipe through the levee, 8 feet below the crown. Drainage pumping plant
on the landside (LS). Flap gate on the waterside (WS) end. Steel
plate welded on end of pipe at LS toe. (Automatic Board Order (ABO)
issued as Permit No. 11467, 1975 - Modglin][Additional
Reference(s): DWR Levee Log, 2005. USACE Sacramento O&M
Manual 506.3, August 1961, (HLM 7.19)].
FS Date: 11/21/2016 12:16:52 PM

Pumping plant in shed on LS at drainage ditch.

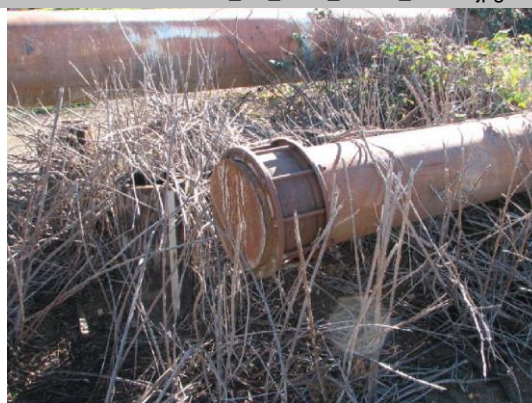
Photo 2 of 2 : UCIP_FA_2016_50827_46883.jpg

Steel plate welded over end of pipe at LS toe.
